AFWAL-TR-80-2043

EVALUATION OF EXPLOSAFE EXPLOSION SUPPRESSION SYSTEM FOR AIRCRAFT FUEL TANK PROTECTION

EXPLOSAFE DIVISION
Vulcan Industrial Packaging Ltd.
Rexdale, Ontario
Canada M9W 5C3

Final Report July 1977 - July 1980

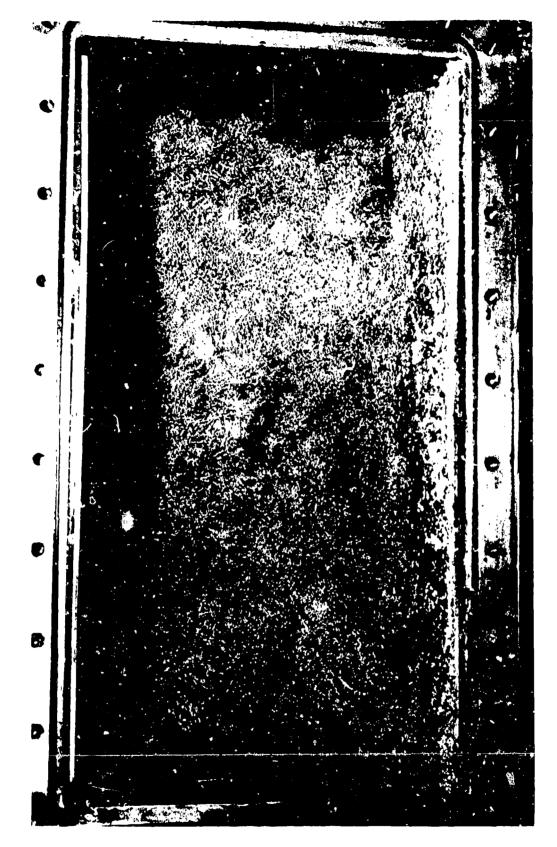
Damage Inflicted on 1.5 mil Explosafe Material by 23mm HEI-T Figure 18.

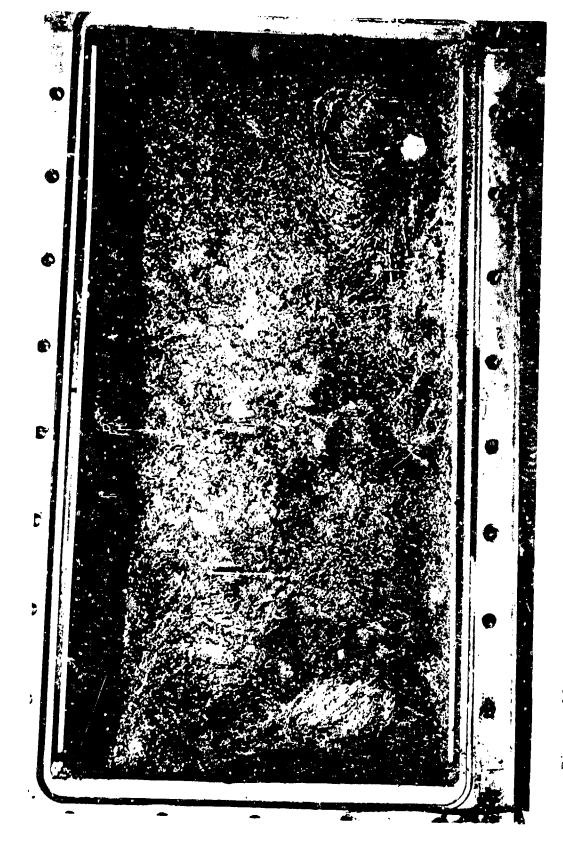
Damage Inflicted on 2.0 mil Explosafe Material by 23mm HEI-T Figure 19.

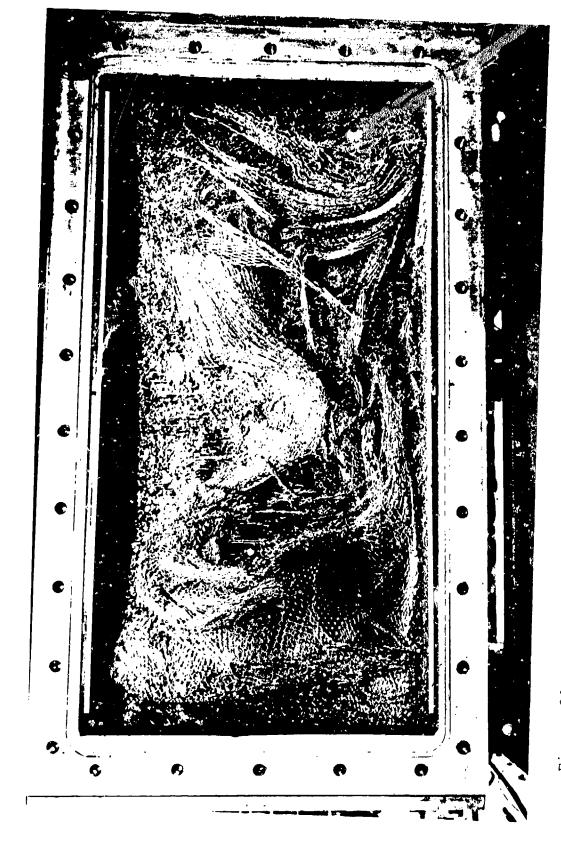
Dəmage Inflicted on 3.0 mil Explosafe Material by 23mm HEI-T Figure 20.

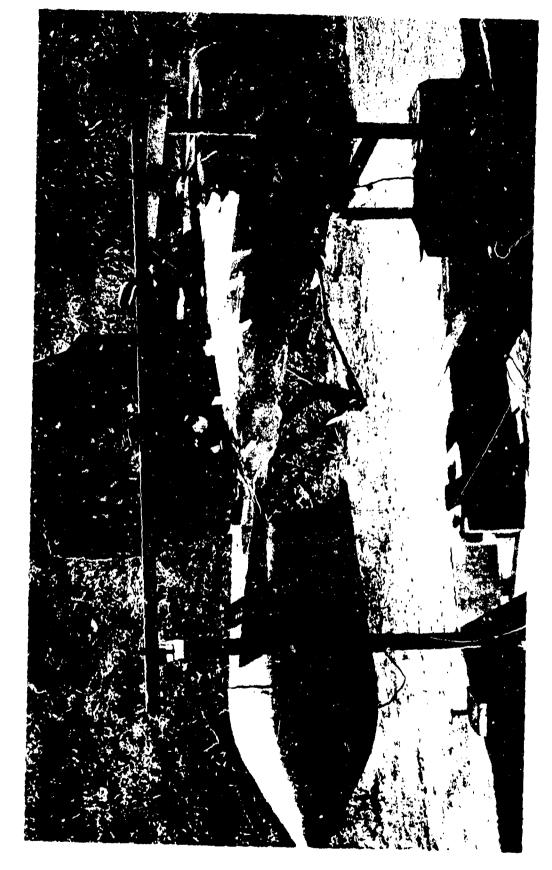
Damage Inflicted on External Wing Tank without Explosafe by 23mm HEI-T Figure 25.

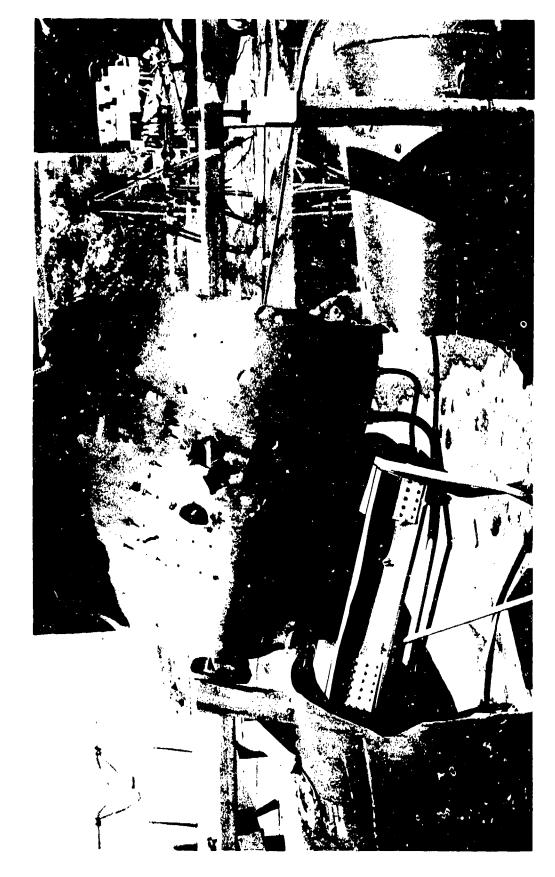
Damage Inflicted on External Wing Tank without Explosafe by 23mm HEI-T Figure 26.

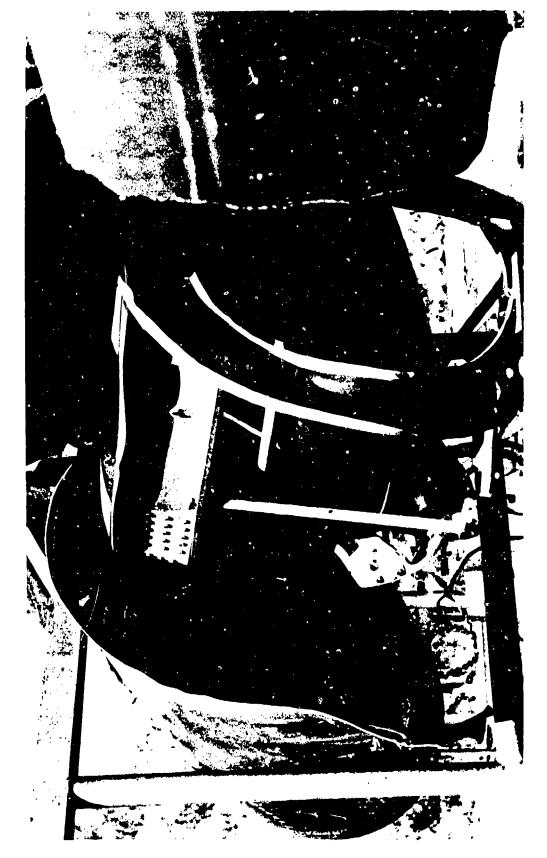
Damage Inflicted on External Wing Tank without Explosafe by 23mm HEI-T Figure 27.

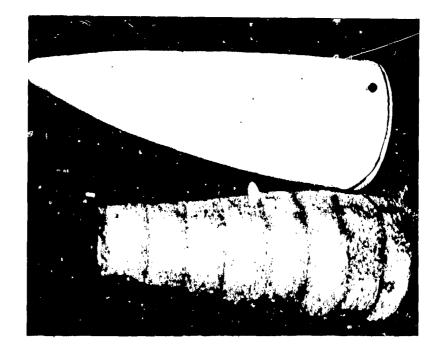
Figure 55. Test 1: Fanfolded Batts of Nose Cone

The coiled batts in the mid-section were seen to move slightly with the slosh. There was no apparent damage to the fanfolded batts of the nose and tail cones (Figures 55 and 56). The foil of the coiled batts, all installed in the mid-section, was significantly fatigued such that it was seen to break off at the edges. The coil packed at the aft end of the mid-section was telescoped and visibly disintegrated around the edges (Figure 57). Some volume of foil debris was generated as a result. Additional foil debris was produced by the internally projected drain fitting scraping locally against the bottom of this coil (Figure 58). All the coils became fairly loose and lacked the firm body of the fanfolded batts. Figure 59 shows one such coiled batt after test. Fanfolded batts of the nose and tail cones had shrunk about 2 percent over their expanded dimension while no shrinkage was noticed in the direction perpendicular to the direction of expansion.

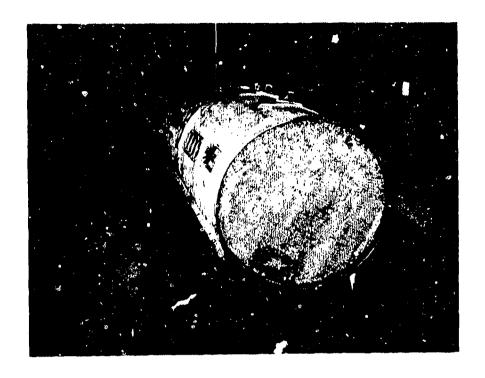
Figure 60. Test 2: Batt at Aft End of Midsection Rotated 4 Degrees

The batt at the aft end of the midsection had rotated about 4 degrees counter-clockwise (Figure 60). This batt lies adjacent to the aft baffle. The fwd face of the batt is voided to accommodate the sharp, protruding lip which lies asymmetrically on the baffle. When the batt rotated, the position of the void no longer coincided with that of the lip. Consequently, the lip cut into the foil causing damage around the voided area (Figure 61). All other batts remained intact and showed no evidence of damage. Figures 62 through 65 show after-test pictures of batts installed in the tank.

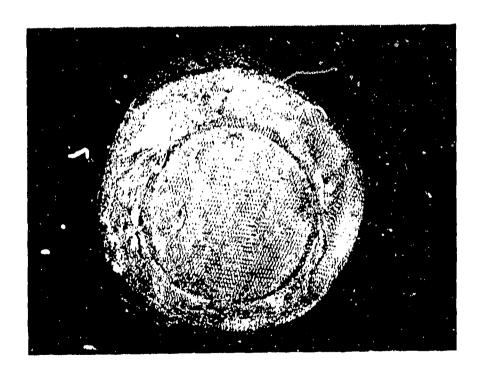
Figure 61. Test 2: Damaged Fwd Face of Batt from Aft End of Midsection

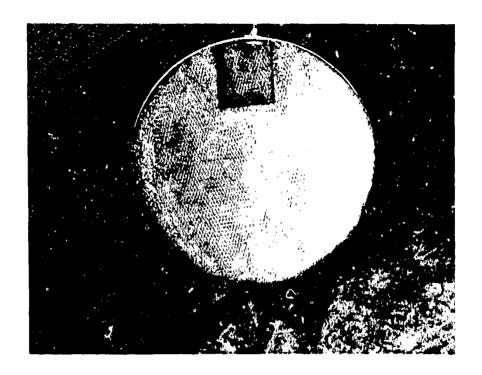
Figure 66. Test 2: Batts at Mouth of Tail Cone Rotated 3 Degrees

The batt at the mouth of the tail cone, which contained the void simulated for a level control valve component, had rotated about 3 degrees counter-clockwise (Figure 66).

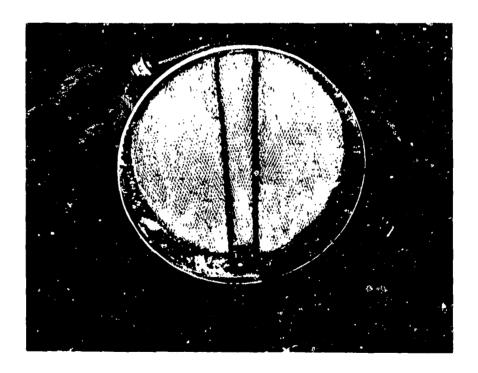
Figure 67. Test 2: No Rotation of Sealant-Anchored Batts in Nose Cone

The sealant strips in the nose cone served their intended function of anchoring the affected batts. No rotation of the anchored batts containing the critically located filler void was noticed (Figure 67).

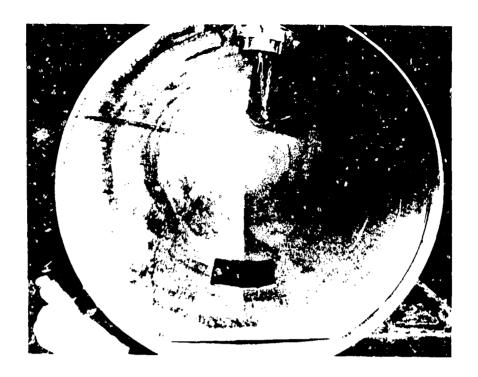
Figure 73. Test 1: Foil Caused Stains in Nose Cone

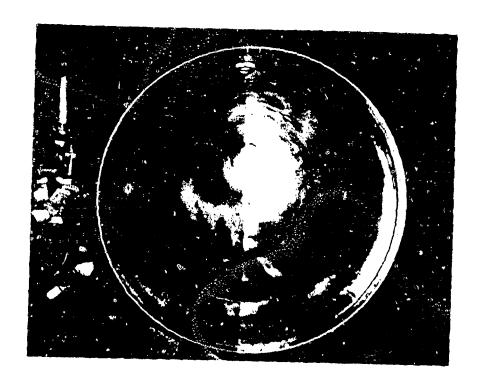
Figure 75. Test 1: Foil Caused Stains in Tail Cone

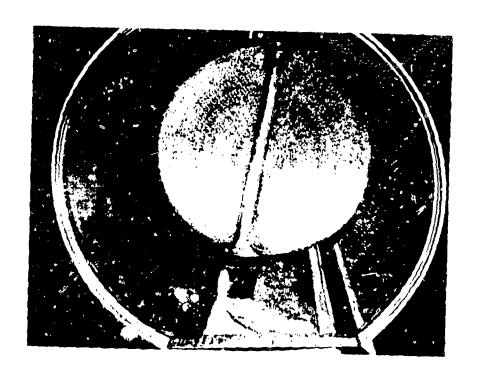
Figure 76. Test 1: Foil Caused Stains at Fwd End of Midsection

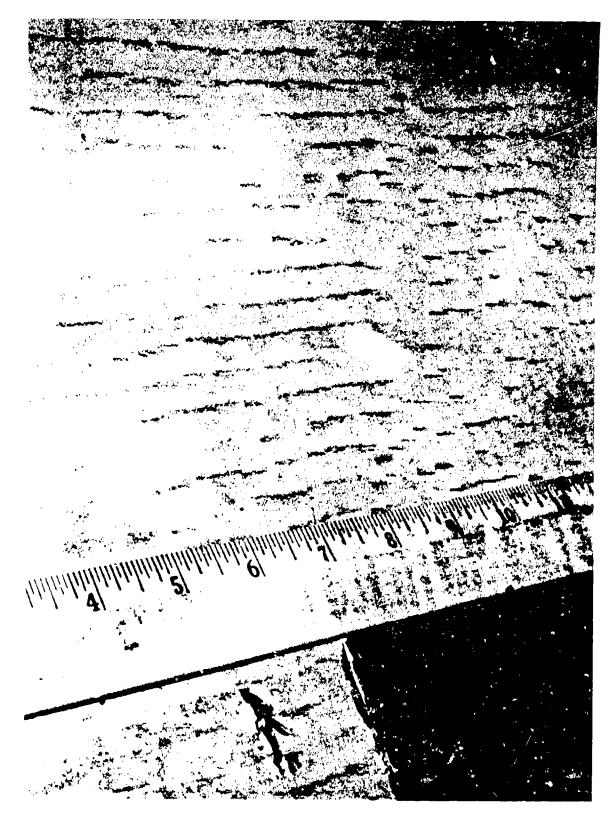
Figure 77. Test 1: Close-Up of Stains at Fwd End of Midsection

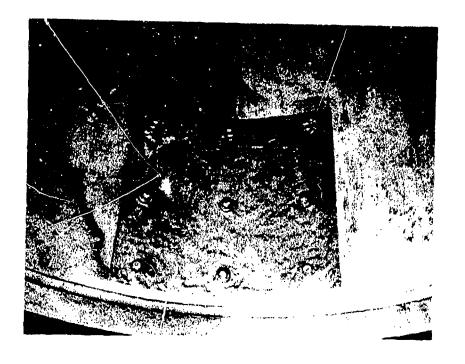
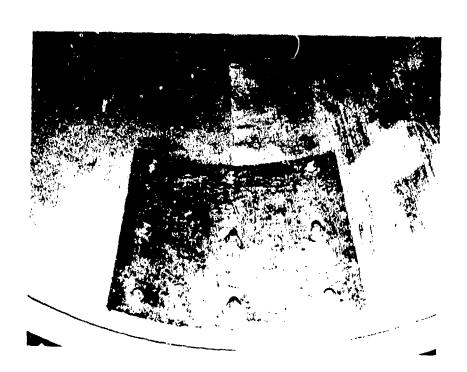
The wear on both the old and new topcoating was similar to that observed in areas where fanfolded batts were installed in the first test. Here too, the aluminum oxide deposits could be easily removed with Metalprep solvent, revealing the underlying paint to be in very good condition (Figure 79).

Figure 79. Test 2: Paint Surface in Tail Cone Before (top) and After Cleaning with Solvent

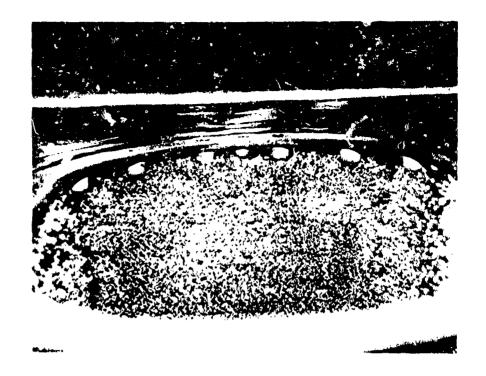
Severe settling and compacting of any explosion suppression material, under operating conditions, could be detrimental to its intended function. Explosafe, when subjected to intense slosh and vibration, does not appreciably settle or compact, reducing

Figure 85. Level of Foil after Test Showing Almost No Settling

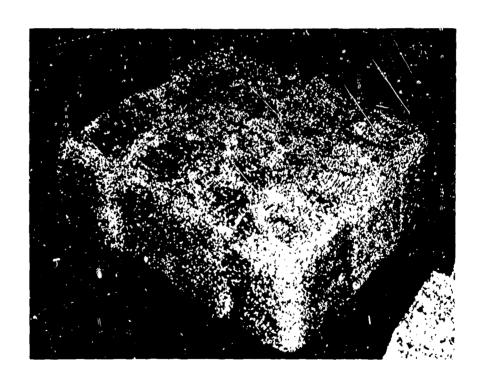
Figure 86. Top Layer of Batts after Test

be directly identified as having occurred during testing. The top and bottom batt layers, as they appeared after testing, are shown in Figures 86 and 87, respectively.

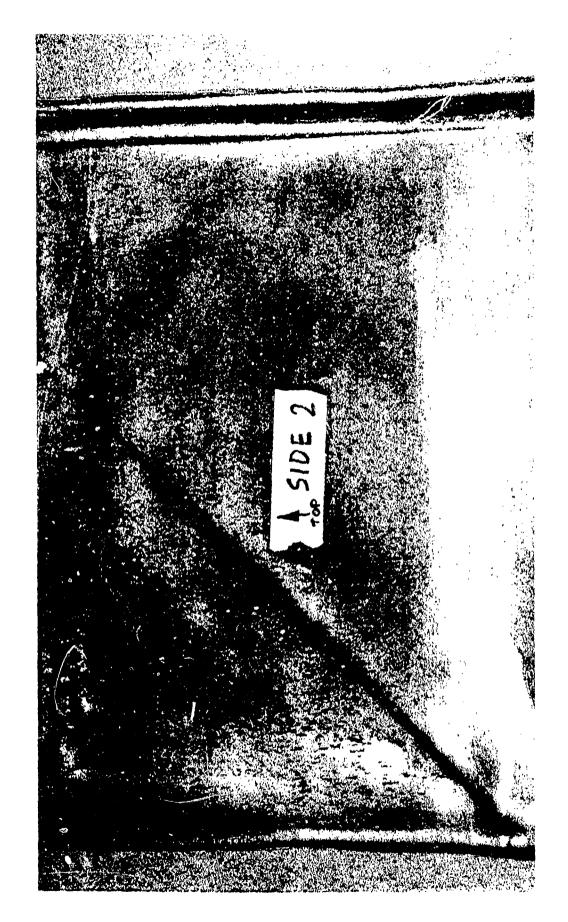
3 Showing Clusters of Minute Scuff Marks

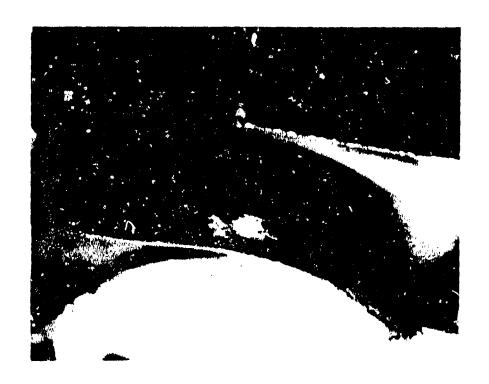
Figure 102. Corresion of Explosafe in Tap Water 20% FSII/50% JP-4 Mixture

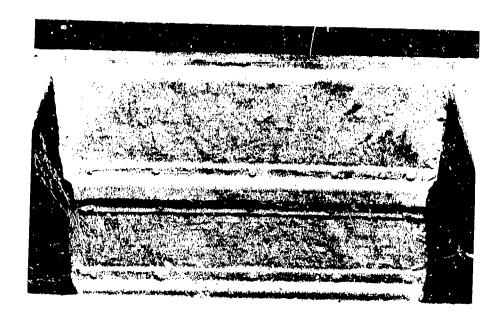
There were slight scratch marks apparent on the tank walls, mainly caused by insertion and removal of the CFAM pack after each 24 hour period. There were also smear deposits of aluminium oxide on the walls.

and some aluminium oxide deposits. See photographs 1 to 4 for comparisons before and after. Final visual inspection (first time the pack of CFAM was unfolded for inspection) showed one slight tear in material. (See photo 5). Typical sharp crease distortion shown in photo 6.

Figure C4-6. Photograph 4: Interior of Test Tank showing Scratch Marks on Primer Paint Lining (After Tests)

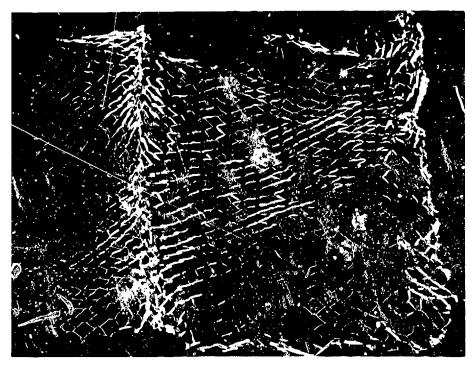
Figure C4-7. Photograph 5: Portion of Me.h from Top of Pack (After Tests)

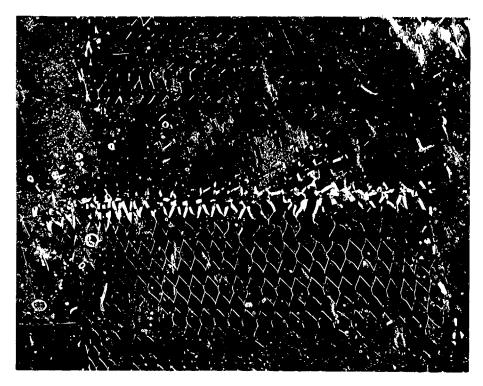
Figure C4-8. Photograph 6: Portion of Mesh from Middle of Pack (After Tests)
